## Reserve Fund Analysis Report

*New Study with Site Visit*  
**POA of Lake Ridge**  
**Cedar Hill, TX**

Report #:	9350
Inspection Date:	February 26, 2019
For Year Beginning:	January 1, 2020
For Year Ending:	December 31, 2020
Date Prepared:	April 9, 2019
Prepared by:	Richard Hamilton RS, PRA
Report Status:	<b>Final-</b>

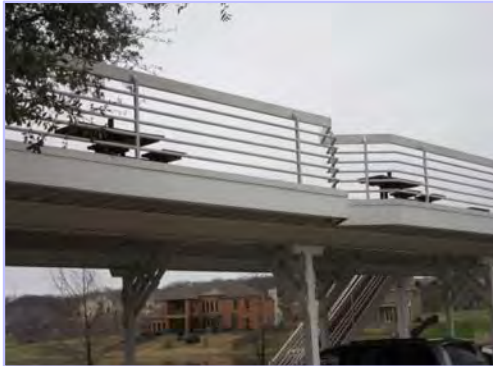
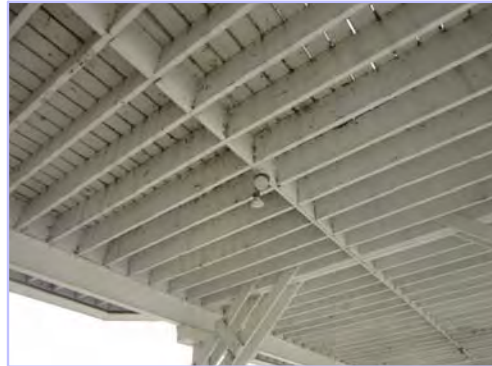
**Deck Substructure - Repair**

The deck substructure consists of metal and wood framing attached metal columns. The frame is showing signs of rust and deterioration in some areas. We anticipate an ongoing program of truss and post replacement to maintain deck integrity.

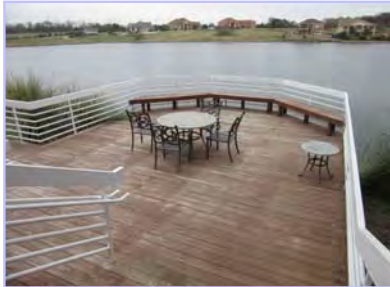
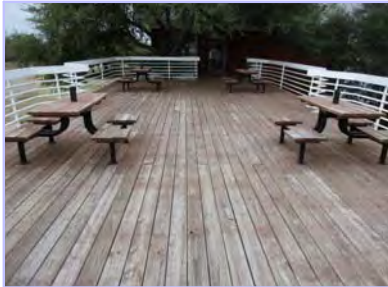
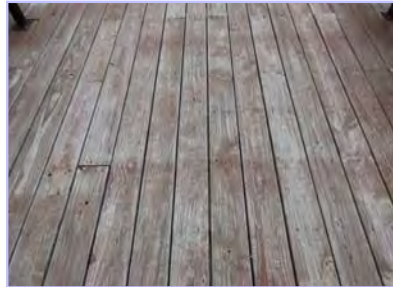
The wooden deck surface located at the upper deck (1,648 GSF), lower deck (1,075 GSF) and walkway (176 GSF), located at the community center is in overall fair condition with noted weathering of the wood sealer. Recommend repairing any trip/fall hazards immediately as noticed and inspect regularly for any damage. Reseal regularly to mitigate any subsurface moisture which will accelerate deterioration. Funding is to replace all decking at one time to maintain consistency and appearance.

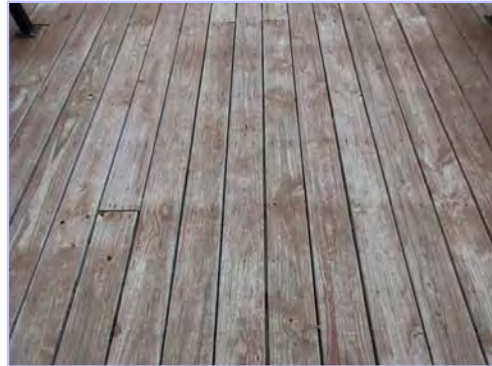
The wood decking surface sealer located at the community center appears in overall fair to poor condition with noted areas of fading or missing sealer. Recommend periodic inspections to ensure proper maintenance, repair any damage, and verify if deterioration is consistent with expectations. Seal regularly to prevent moisture penetration which will accelerate deterioration.

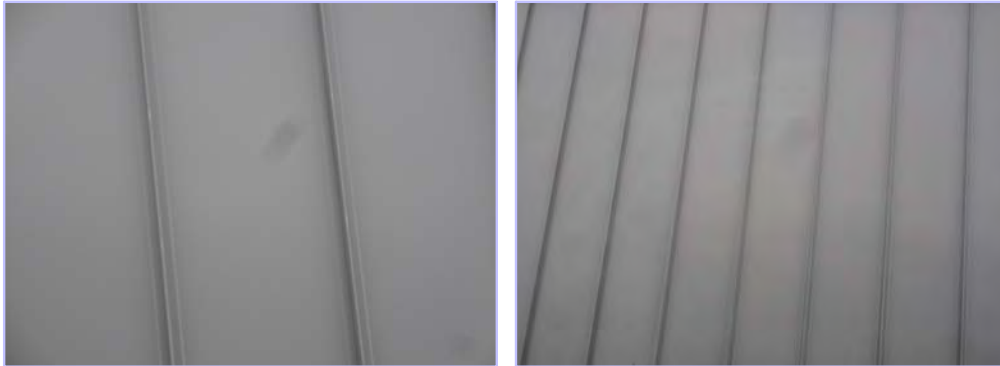
The corrugated metal roof on the clubhouse appears in overall good condition and is reported to have been replaced in 2017. Recommend yearly inspections by a qualified roofer to ensure proper maintenance, repair any damage, and verify if deterioration is consistent with expectations.

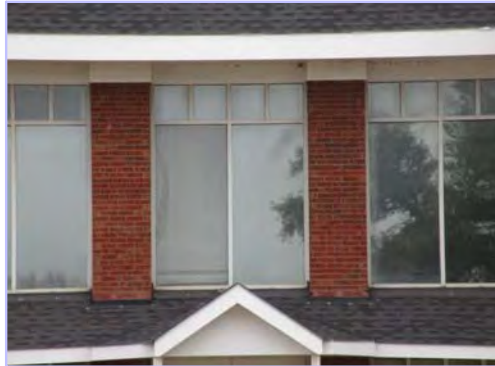
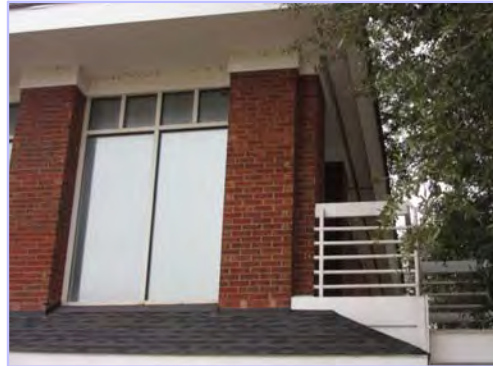
The (81) Windows, including the 54-window mosaic at the rear of the building, and (7) doors appear to be in overall good condition. We assume windows were installed without defect and include sufficient underlying waterproofing details. As routine maintenance, we recommend regular professional inspections. Repair as needed to ensure good weather seal and help prevent structural damage. With ordinary care and maintenance, plan to replace windows at roughly the time frame indicated. Note: for pricing, we have counted each set of double doors as two doors each.

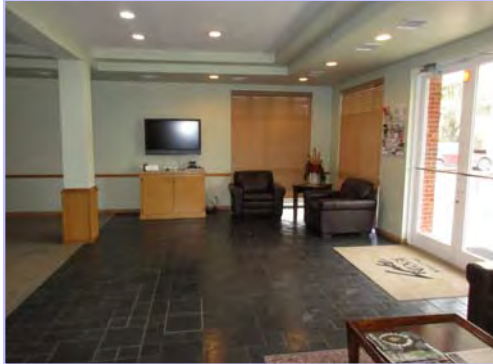
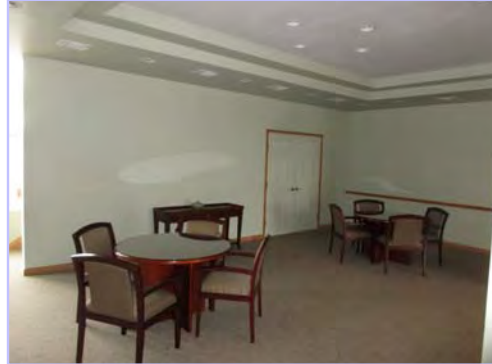
Interior walls are painted and in good condition. Anticipate repairing and repainting to ensure a quality appearance.

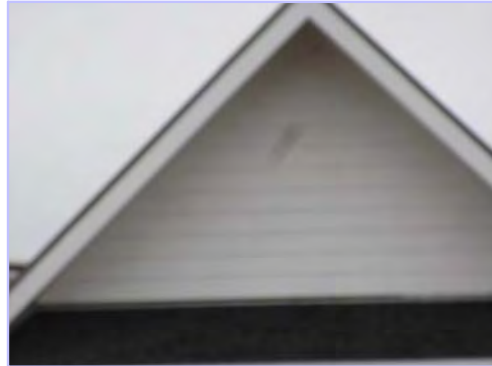
Paint is in generally good condition with minimal areas showing signs of fading, peeling, dry and missing or cracked caulking. Recommend caulking around areas of wood to brick transition. Preventing moisture penetration via cracks (wood shrinking around transitions) is key in ensuring a full useful life.

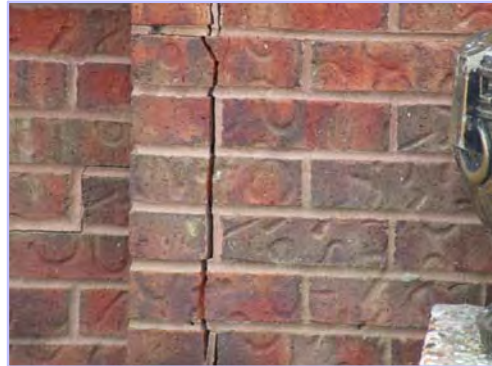
The brick veneer siding appears in overall good condition with no noted areas of damage or missing grout, but one small area of cracked brick, possibly from foundation movement. Recommend periodic inspections to ensure proper maintenance, repair any damage, and verify if deterioration is consistent with expectations. Repoint brick periodically to prevent subsurface moisture penetration which will accelerate the deterioration of this component.

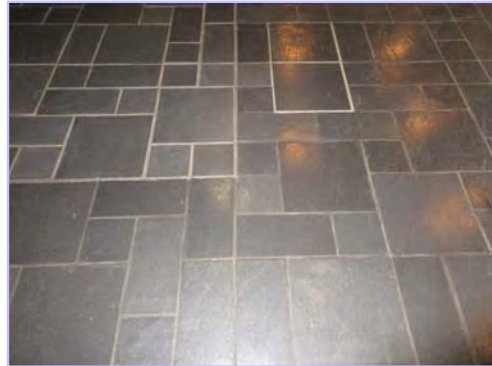
The tile flooring utilized throughout the clubhouse is in good condition. Floor should be cleaned, polished and sealed periodically to maintain appearance and to maximize useful life. Funding anticipates eventual replacement due to age and changes in design tastes.

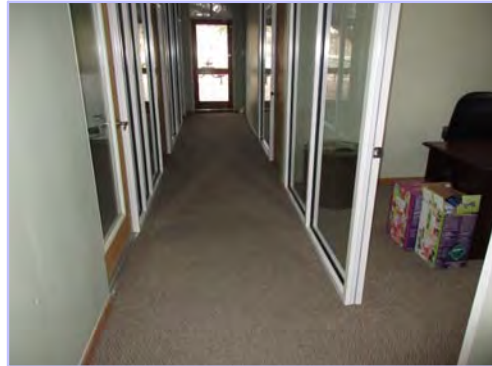
The rental area hallway and common area carpet, which includes the stairs and turret, is a typical medium grade commercial carpet and is in worn and stained condition in areas. Recommend regular cleaning to maximize useful life.

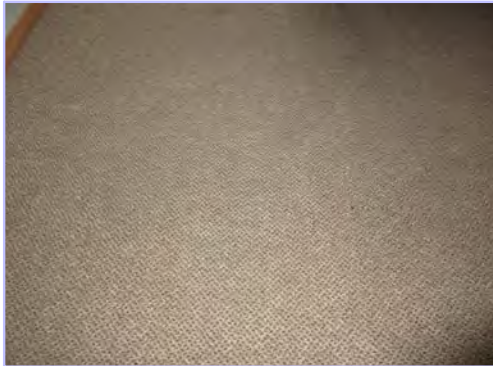
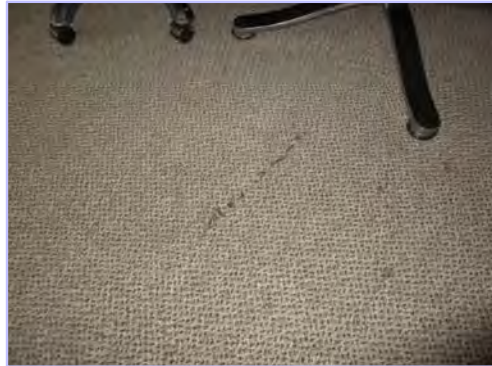
Commercial grade carpet used throughout the office, conference and lobby areas appears in overall fair condition with some areas of stains or damage. Carpet should be shampooed periodically to ensure maximum useful life.

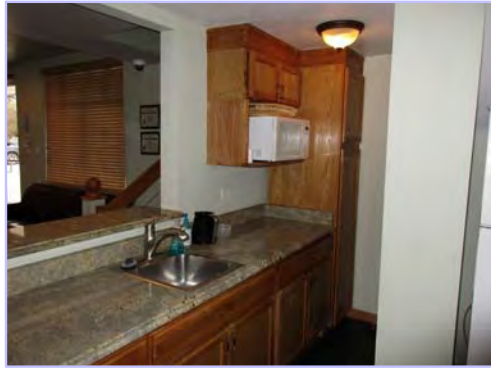
Kitchen appears in good overall condition. Allowance is to replace 40 SF hard surface countertops and 10 LF of wood cabinets due to use and age.

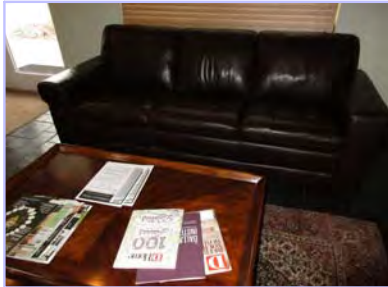
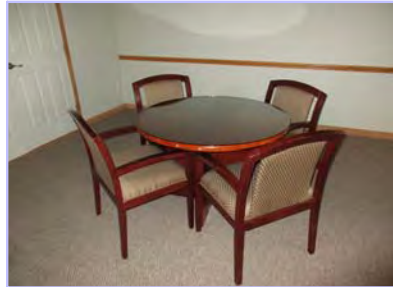
**Lobby Furniture - Replace**

Quantity	1	Allowance
		Asset Cost		\$20,000.00
		Percent Replacement		100%
		Future Cost		\$30,264.03
	Furnishings			
Placed in Service	January 2015			
Useful Life	20			
Replacement Year	2035			
Remaining Life	15

Approximately (15) pieces of furnishings are located in the lobby area. These include couches, chairs, tables and lamps. Commercial grade furnishings can vary widely in cost. We have used mid grade pricing. Funding anticipates periodic replacement of furnishings to maintain the appearance and appeal of the community center.

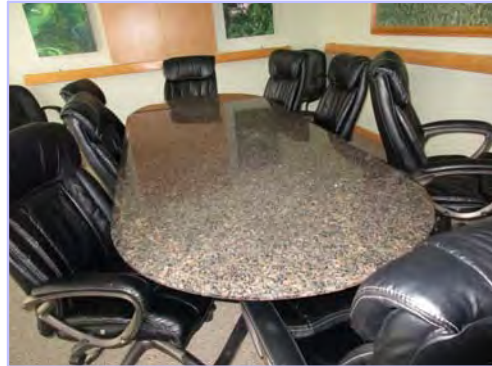
**Meeting Room Furniture - Replace (part)**

Quantity	1 Sets
		Asset Cost	\$2,700.00
		Percent Replacement	100%
		Future Cost	\$3,558.73
	Furnishings		
Placed in Service	January 2015		
Useful Life	15		
Replacement Year	2030		
Remaining Life	10

General meeting and party room furniture inventory includes: (1) conference table; (10) chairs and (1) TV monitor. Funding anticipates replacing the furnishings on a regular basis due to wear and use.

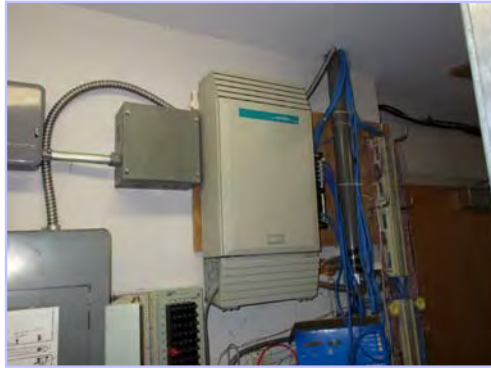
**Phone System - Replace**

Quantity	1 Each
		Asset Cost	\$7,000.00
		Percent Replacement	100%
		Future Cost	\$9,226.33
	Building Interior		
Placed in Service	January 2000		
Useful Life	30		
Replacement Year	2030		
Remaining Life	10

The office phone system appears to be in operational condition, with no reported problems. Multi-line systems have evolved rapidly over recent years with hosted PBX systems gaining popularity due to the reduced equipment costs. We have factored a hybrid system which incorporates some switching equipment hosted locally and requiring the purchase of handset equipment. The current system will need eventual replacement due to the lack of availability of parts.

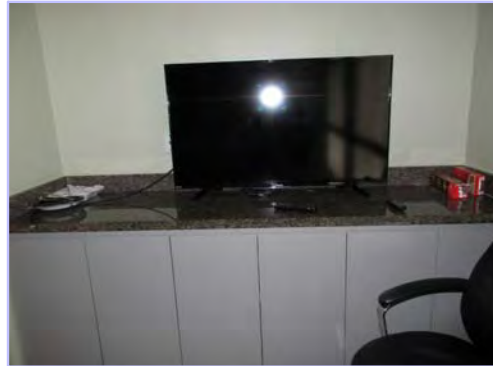
**Office Equipment - Replace**

Quantity	1	Allowance
		Asset Cost		\$2,500.00
		Percent Replacement		100%
		Future Cost		\$2,641.96
	Furnishings			
Placed in Service	January 2017			
Useful Life	5			
Replacement Year	2022			
Remaining Life	2

The computer equipment is used throughout the office area. Equipment appears to be in overall good condition and operating properly. Funding anticipates replacement due to age and changes in technologies.

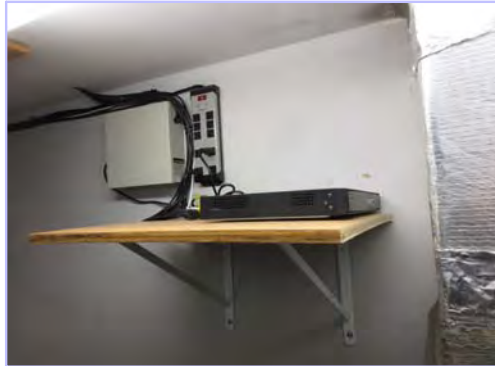
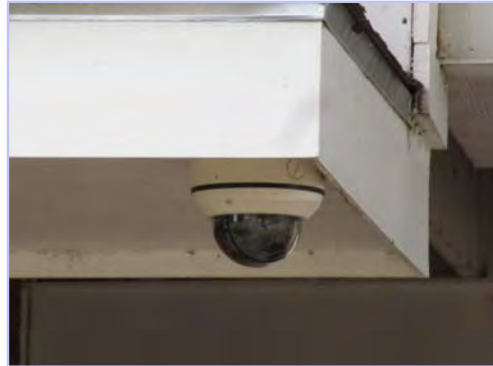
**Security Equipment - Replace**

Quantity	1 Each
		Asset Cost	\$5,000.00
		Percent Replacement	100%
		Future Cost	\$5,901.04
Placed in Service	Security		
Useful Life	January 2016		
Replacement Year	10		
Remaining Life	2026		
	6

The security monitoring system was reportedly refurbished in 2016. Anticipate regular upgrades and replacements to this system to maintain safety/security as well as for changes in technology.

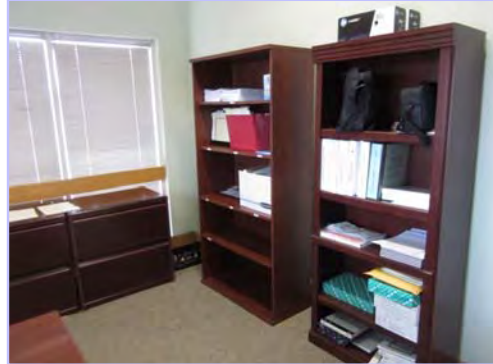
**Office Furniture - Replace**

Quantity	1	Allowance
		Asset Cost		\$3,000.00
		Percent Replacement		100%
		Future Cost		\$3,954.14
	Furnishings			
Placed in Service	January 2015			
Useful Life	15			
Replacement Year	2030			
Remaining Life	10

Furniture located in the office areas are in good condition. Inventory includes: (3) desks, (3) bookcases, (10) chairs and (1) file cabinet. Anticipate replacing pieces on a regular cycle to maintain property's appearance and aesthetics. Furnishings should have an extended useful life. Funding anticipates replacing pieces of furniture (approximately 50%) as needed with no anticipation of replacing all furnishings at one time. Due to use, furnishings will wear at differieng rates.

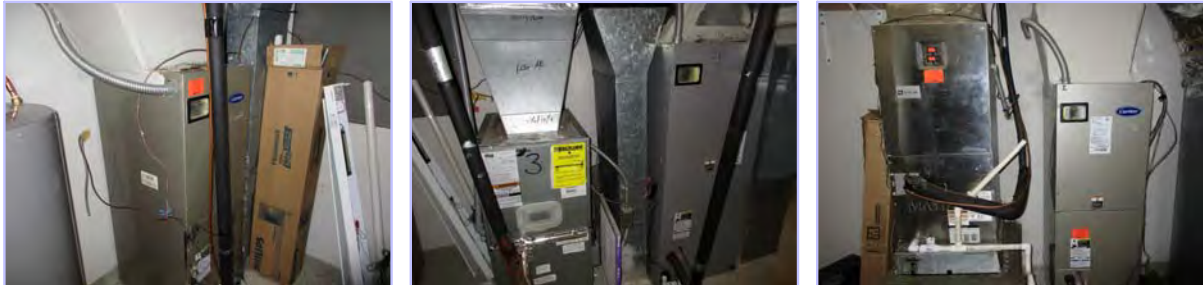
The gas furnaces are located in the rental floor area and appear to be in overall good condition with install dates ranging from 2000 to 2016. Recommend regular service in accordance with manufacturer's guidelines to ensure full useful life. Funding anticipates continued replacement of units on an as needed basis with no anticipation of replacing all units at one time.

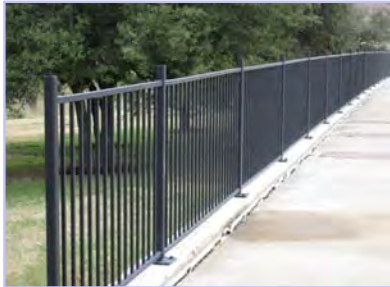
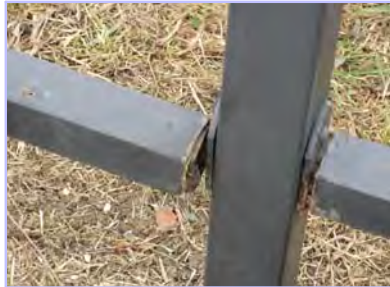
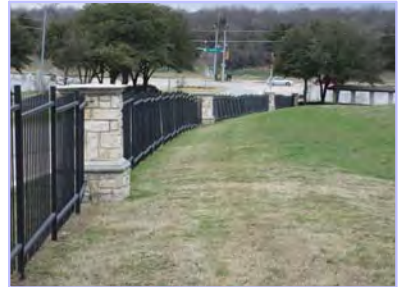
Metal is in fair condition with limited signs of rust or damage, but some broken welds. Fence has a powder coated finish that once damaged will require restoring and protecting surface from moisture. Due to prohibitive costs of removing fence to re-powder coat, funding is based on maintaining fence by treating rust and painting. Recommend periodic inspections to identify and treat damaged areas in order to avoid additional future costs to repair.

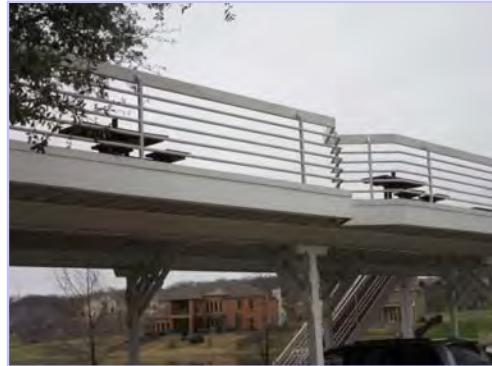
Metal railing provides fall protection at the upper and lower clubhouse deck. Metal is in good to fair condition with limited signs of rust or damage. Metal has a powder coated finish that once damaged will require restoring and protecting surface from moisture. Due to prohibitive costs of removing rail to re-powder coat, funding is based on maintaining metal surfaces by treating rust and painting. Recommend periodic inspections to identify and treat damaged areas in order to avoid additional future costs to repair.

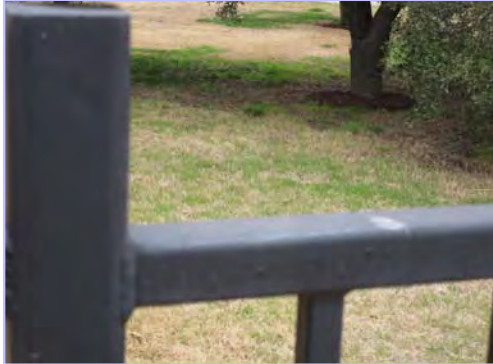
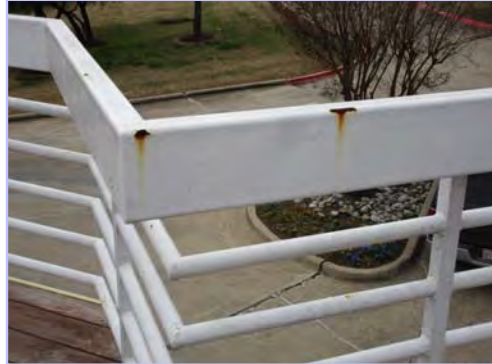
Metal fence and railing surface appears in overall fair to poor condition. Metal surfaces have a powder coated finish that once damaged will require restoring and protecting surface from moisture. Due to prohibitive costs of removing metal to re-powder coat, funding anticipates regular cycles of paint, utilizing a high quality exterior metal surface product. Remove rust and apply a rust inhibitor prior to painting.

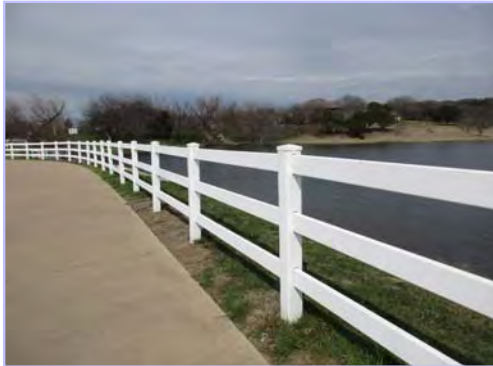
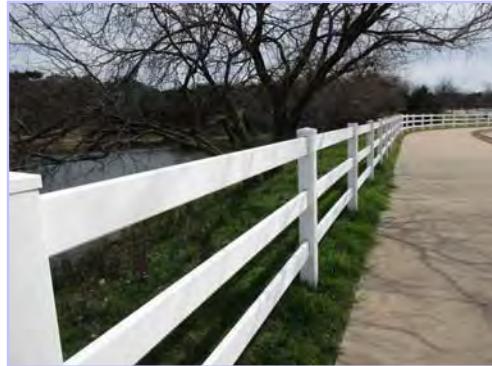
Vinyl rail fence is used to accent the parking area at Ridge View Park. Vinyl fence is in good condition with minimal signs of warped or damaged rails. Recommend periodic inspections to identify and treat damaged areas in order to avoid additional future costs to repair.

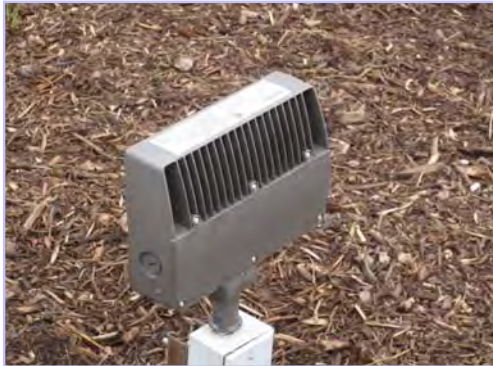
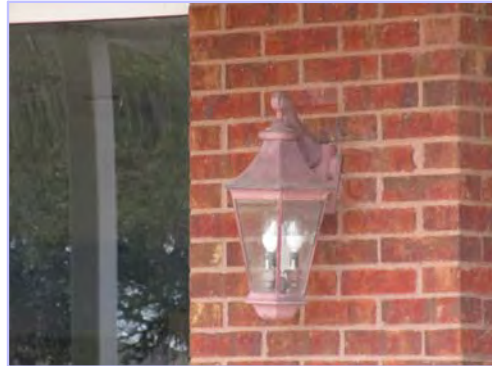
**Exterior Lighting - Replace**

Quantity	1	Allowance
		Asset Cost		\$2,500.00
		Percent Replacement		100%
		Future Cost		\$2,870.16
	Lighting, Exterior			
Placed in Service	January 2010			
Useful Life	15			
Replacement Year	2025			
Remaining Life	5

Light inventory includes ground, recessed and wall mounted fixtures. Anticipate replacing items on an as-needed basis with no anticipation of replacing all items at one time.

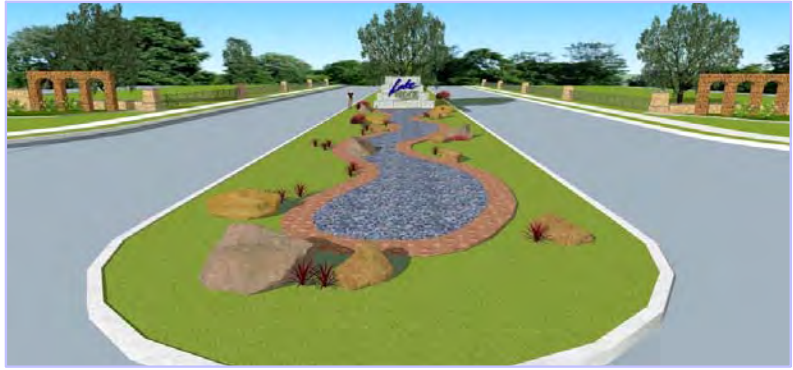
**Monument Sign - Refurbish**

Quantity	1 Each
		Asset Cost	\$30,000.00
		Percent Replacement	100%
		Future Cost	\$50,697.95
	General Common Area		
Placed in Service	January 2019		
Useful Life	20		
Replacement Year	2039		
Remaining Life	19

A new monument and entrance sign is scheduled to be installed in 2019. Anticipate repairing or refurbishing stonework and landscape areas on a cyclical basis with no anticipation of replacing the complete sign. Funding is based on drawings and plans as well as installation estimates.

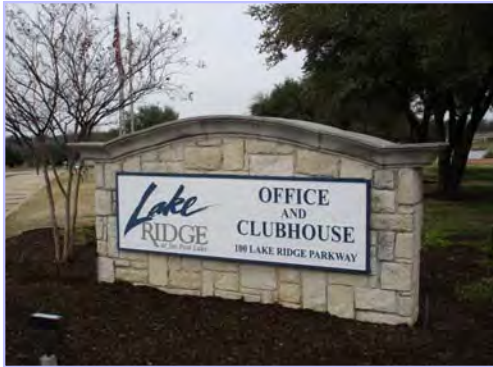
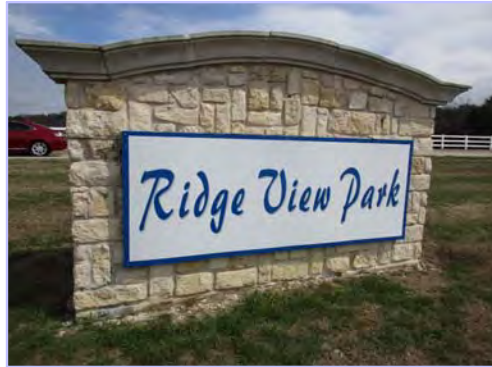
Signs are a combination of stone and concrete and provide information and park names. Signs are in good to fair condition overall. Anticipate repairing or refurbishing signs on a cyclical basis with no anticipation of replacing all signs at one time.

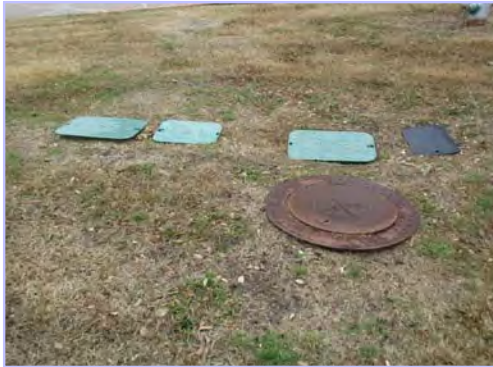
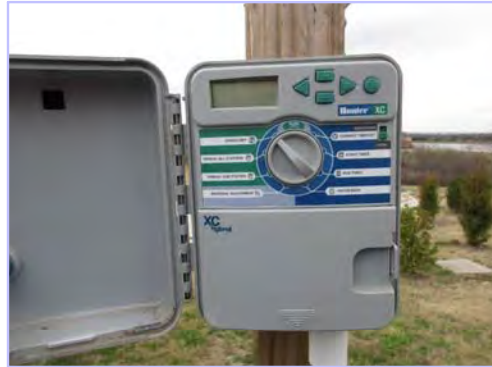
**Irrigation System - Replace (partial)**

Quantity	1		Allowance
	Asset Cost			\$15,000.00
	Percent Replacement			100%
	Future Cost			\$18,198.81
Landscape and Equipment				
Placed in Service	January 2017			
Useful Life	10			
Replacement Year	2027			
Remaining Life	7

Irrigation system is typically repaired on an as-needed basis as part of the landscape contract. Occasionally, extensive repair and replacement of large sections of the irrigation system are necessary as provided herein. Anticipate an allowance to repair sections of the irrigation system or higher cost components such as clocks and backflow prevention devices.

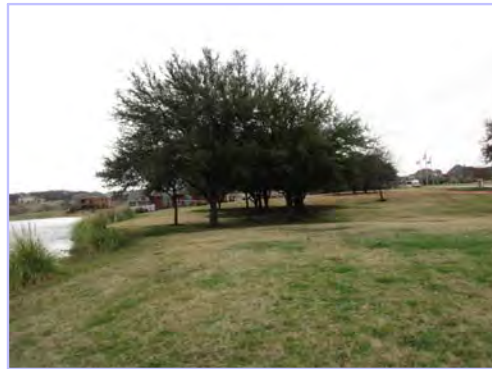
**Trees/Vegetation - Replace (partial)**

Quantity	1
	Asset Cost	\$20,000.00
	Percent Replacement	100%
	Future Cost	\$24,265.08
Landscape and Equipment		
Placed in Service	January 2017	
Useful Life	10	
Replacement Year	2027	
Remaining Life	7

Trees and vegetation are mature and appear in overall good condition. Funding is for ongoing replacement of trees and vegetation due to winter kill and disease. We recommend consulting with a licensed arborist prior to tree replacements.

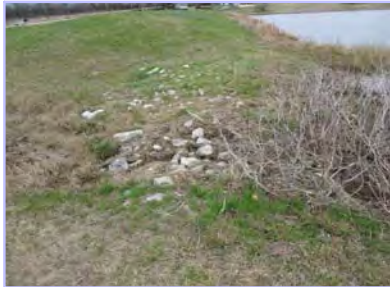
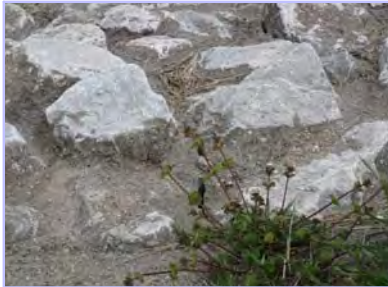
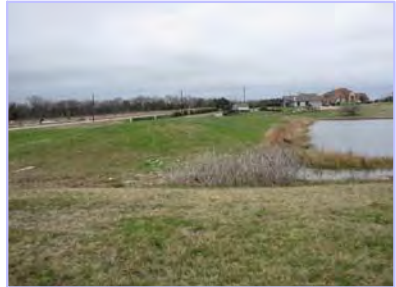
The community is responsible for (3) lake earthen dam walls within the retention lake system. Homogenous wall systems are typically constructed of a compacted clay core set in an earthen dam, and then covered with vegetation to reduce erosion. Some dam areas have been renovated in recent years. Fill and compact eroded areas to maintain dam integrity. There are several products available to prevent erosion; increased funding may be needed if these products were used.

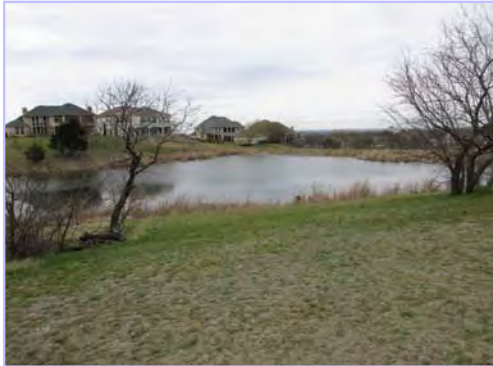
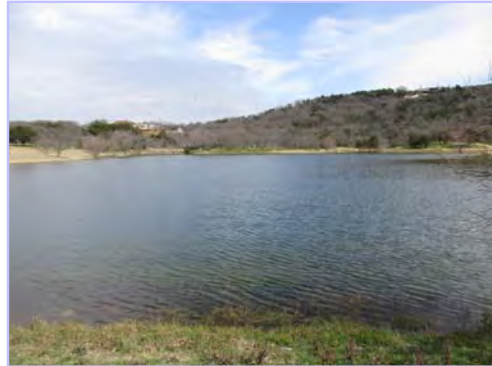
Silt is a combination of vegetation growth and runoff debris. Material should be removed occasionally to ensure proper lake capacity and usability. The association maintains (5) of the ponds located throughout the community that vary widely in size as well as accessibility. Allowance is to dredge and clean portions of the ponds on an ongoing basis as needed.

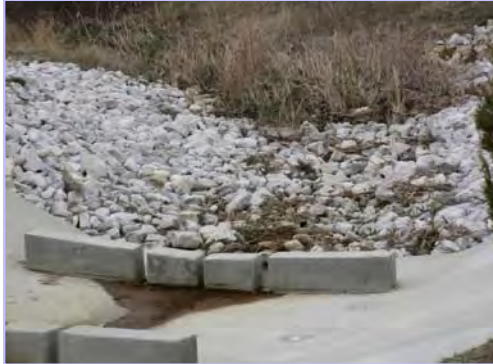
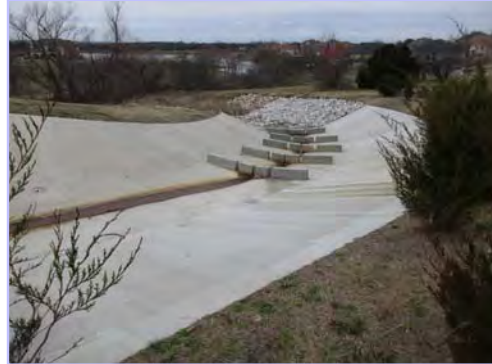
Drainage is a significant issue throughout the community. Drainage swales should be cleaned regularly and rip-rap replaced as needed. Areas should be inspected following each major weather event. Funding anticipates future projects to maintain the systems in proper working order.

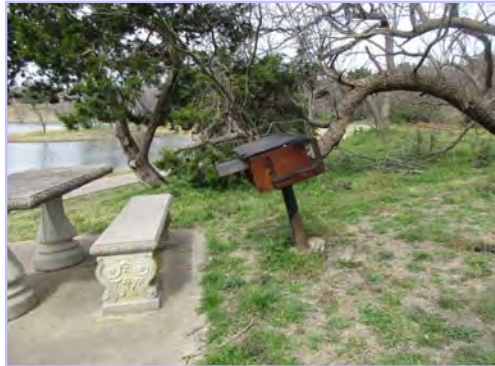
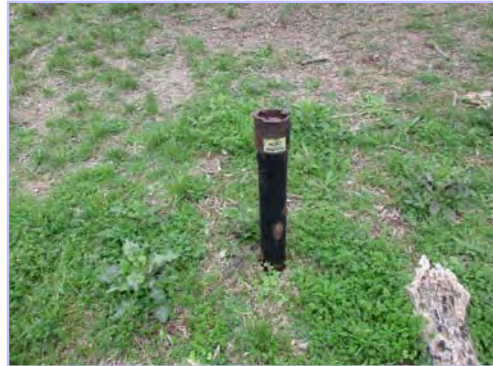
BBQ inventory includes (6) locations at the Ridge View Park trail area, with (4) missing or broken. Funding anticipates an allowance to replace items as needed and as the Board sees fit, with no anticipation of replacing all items at one time.

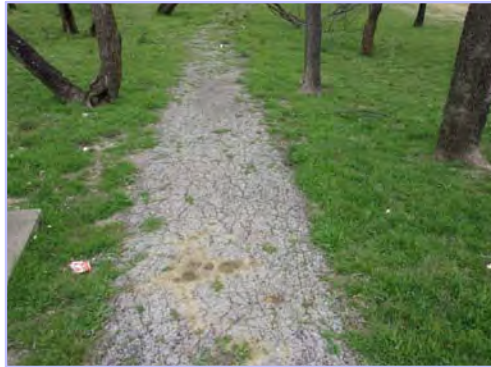
The gravel walking trail at Fossil Ridge Park is in overall fair to poor condition with extensive areas of cracking. Recommend repairing any trip/fall hazards immediately and inspect regularly for any damage. Funding is to repair sections as needed, with no anticipation of replacing all of the trail at one time.

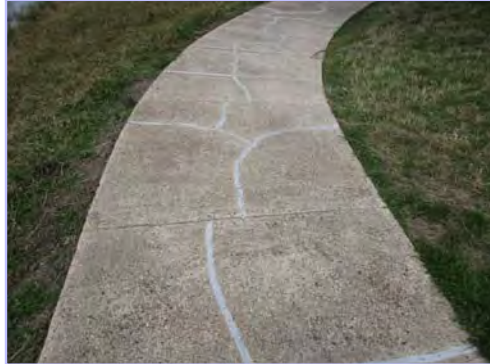
Concrete trail at Ridge View Park is in overall fair condition with areas of cracking and chipping. There was a large amount of erosion noted, where the subsurface soil had washed away. These areas should be filled regularly to prevent cracking and collapse of concrete sections. Recommend repairing any trip/fall hazards immediately and inspect regularly for any damage. Repair and replace concrete to mitigate any subsurface moisture which will accelerate deterioration. Funding is to replace sections of concrete as needed, with no anticipation of replacing all concrete at one time. Funding anticipates replacing approximately 10% per cycle.

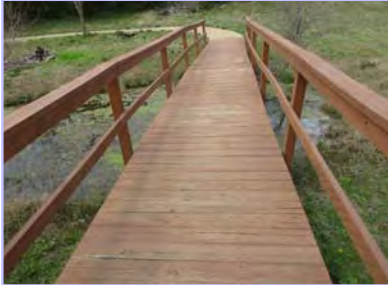
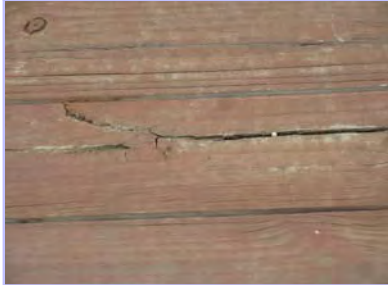
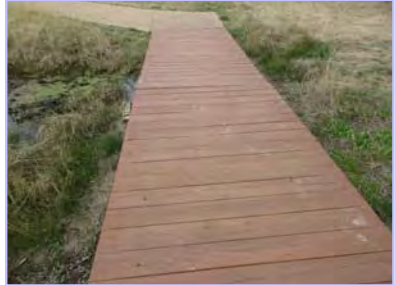
The wood bridges at the Ridge View Park walking trail appear in overall fair condition with slight fading and damage to the wood surface noted. Recommend regular staining or painting to protect wood, and periodic inspection to secure loose components. Anticipate eventual replacement of the wood deck and some structural components due to use and exposure to the elements.

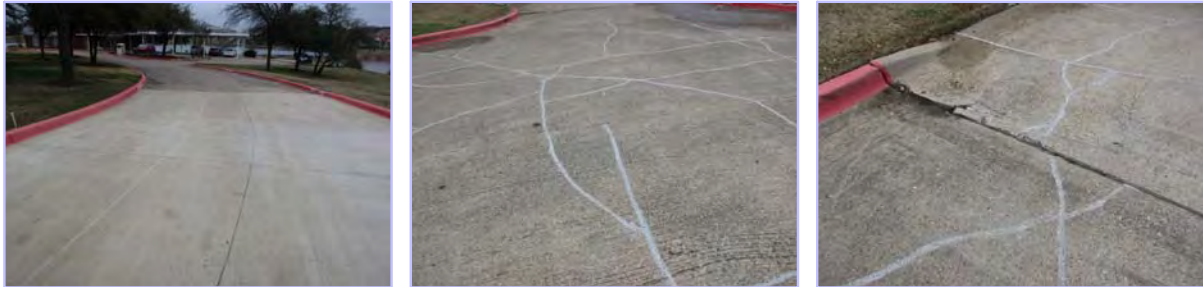
The concrete parking at the Ridge View Park and clubhouse area is in poor condition with areas of cracking and surface deterioration, but no pot holes or depressions. Surface integrity is critical to mitigate any subsurface moisture which will accelerate deterioration. Funding is to replace approximately 10% of the concrete on a regular basis.
